# A fall of ground case study – an improved understanding of the behaviour of a major fault and its interaction with ground support

I.G.T. Thin, B.J Andrew & M.J Beswick

*Xstrata Copper, Mount Isa Mines, Mount Isa, Queensland, Australia.*

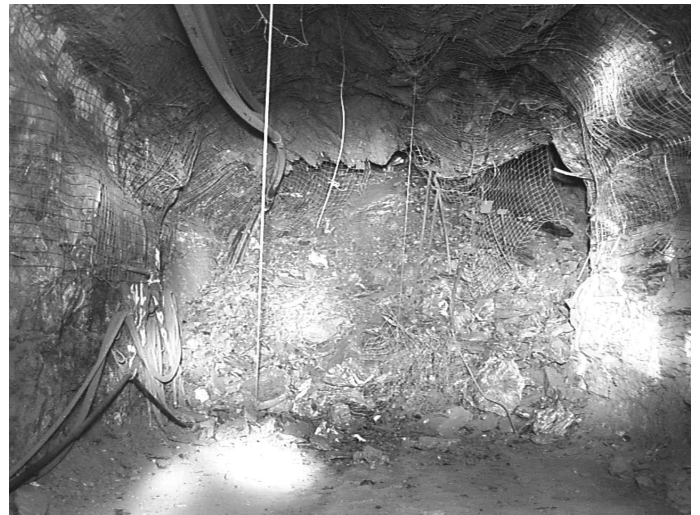
Various technical personnel inspected the area during the remainder of the Night Shift to discover the second fall of ground had covered the Jumbo. The third and final fall was discovered just prior to the end of the shift, where the failure was found to have progressed to the P3849 SEDR and Q369 CO intersection (see Figures 4 and 5).

Figure 5. Looking south at the fall of ground at the point of arresting, at the intersection of P3849 SEDR and Q369 CO, 20B Sublevel.

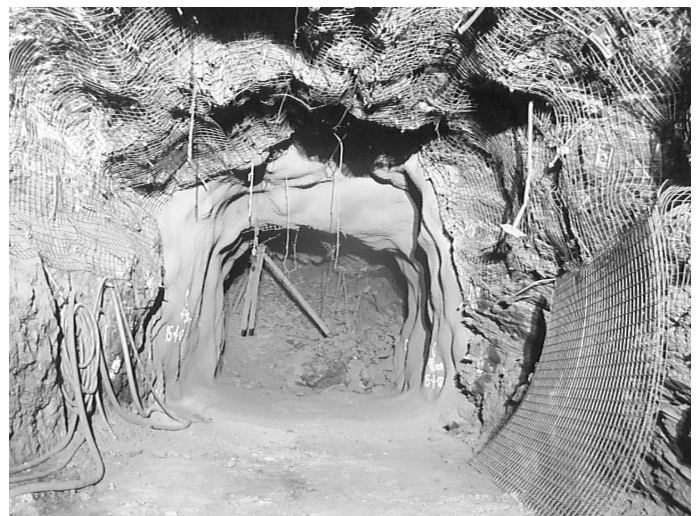
Figure 6. Looking south along P3849 SEDR (20B) at the first stage of the initial rehabilitation process, with the spraying of shotcrete (150 mm) and prior to the installation of the reinforcing cable bolts.

In order to better assess the immediate failure zone, a 150 mm thick shotcrete curtain was sprayed on both sidewalls to the floor and in the back (in affect, creating a shotcrete arch), to a distance of approximately 6.0 metres back north from the point where the failure arrested (see Figure 6). Deep reinforcement was then installed in the back and sidewalls of the drive, from the Q37 TIPAC moving south, with the installation of 9 m long Garford cable bolts. Once this was completed, the unstable brow was then mechanically (and thus remotely) removed, after which there was some limited mucking of the failed material. The immediate failure scar and fall material were then visually inspected and assessed.

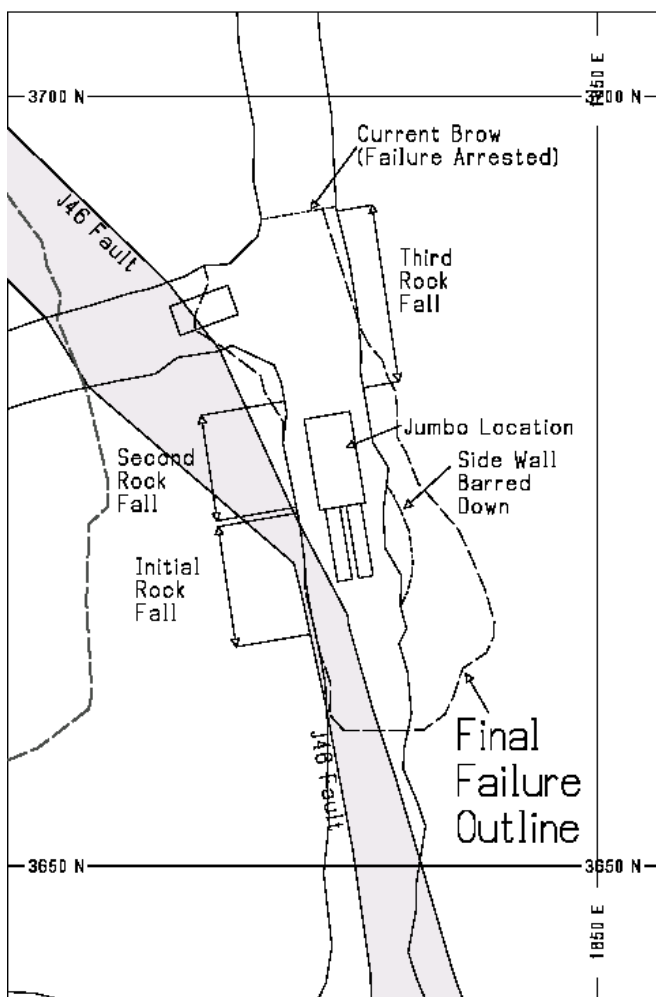
Figure 4. 20B Sublevel mine plan showing details of the sequence of failures and final failure outline (the shaded area represents the floor projection of the J46 fault).

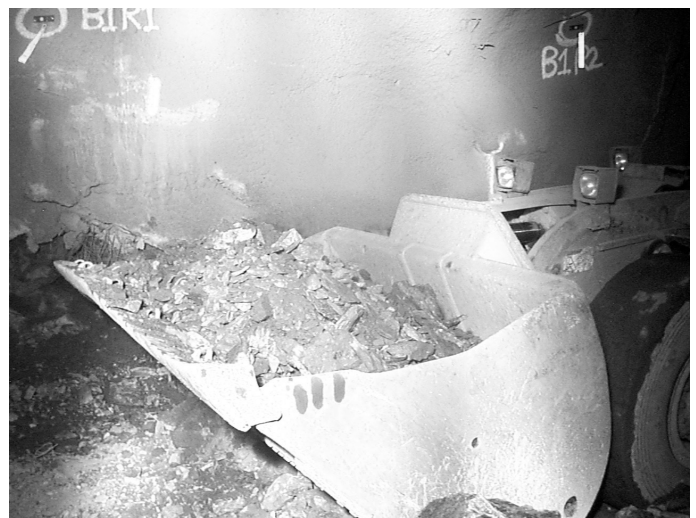
Management of weak, friable and unconsolidated failure material drove the basis for the philosophy and methodology behind the rehabilitation (see Figure 7). The resultant risk assessment identified several hazards associated with a full rehabilitation process of the drive. From this, new controls were identified and a risk management action plan developed. The agreed rehabilitation consisted of:

Figure 7. Typical size of the failure material from J46 fault exposed on P3849 SEDR, 20B (note that the unit mucking from the failure zone is an Elphinstone R1700).

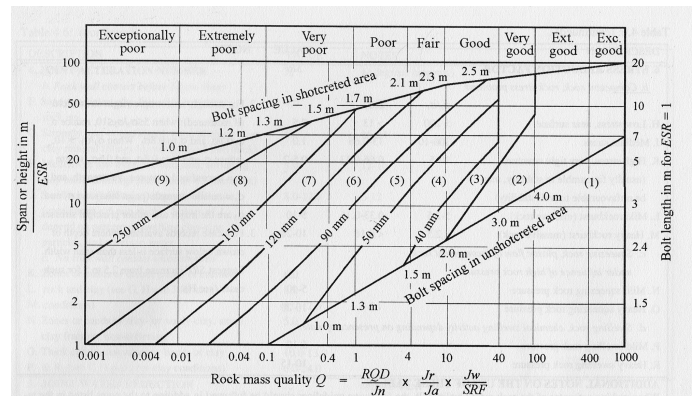
From these parameters, a Q of 0.178 was determined. Then with reference to Figure 8, it can be seen that the empirical estimation of support requirements for a drive with a 5.5 m span equates to bolts and fibre reinforced shotcrete with a thickness of approximately 50 mm. For a drive with a 7.5 m span, this equates to bolts and fibre reinforced shotcrete with an approximate thickness of 90 mm.

Figure 8. Estimated support categories based on the Q-system (Grimstad & Barton, 1993).

Based on this empirical back analysis and engineering judgement, the proposed changes to ground control systems used to maintain drive stability with future exposures of the J46 fault (or any other of the major faults), are to consist of mesh reinforced shotcrete (with an approximate thickness of not less than 100 mm), followed with cable bolts (the length of which will vary from between 6 and 9 m). A cyclic approach of installing this ground control system is certainly preferred over a campaign approach, so as to minimise exposure.

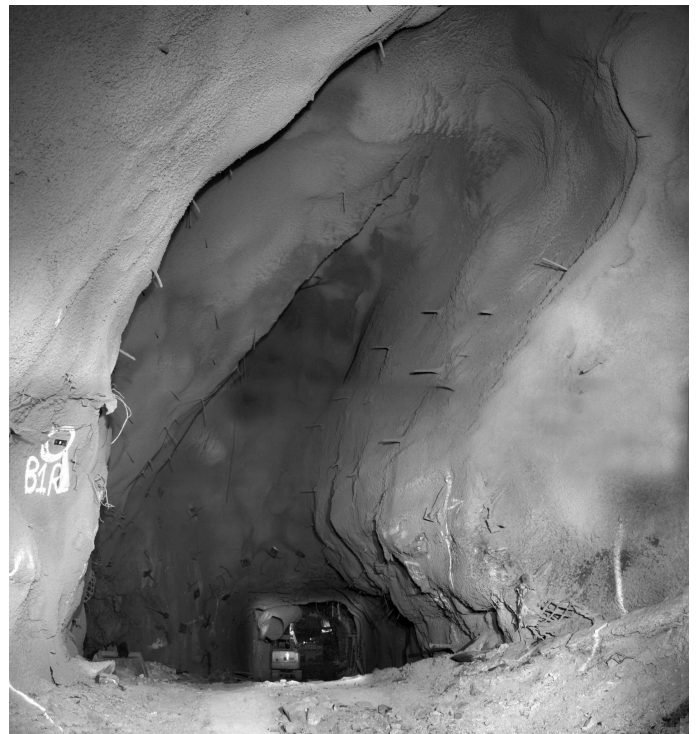
Figure 9. Looking back north along P3849 SEDR (20B) at the failure profile, dominated by the strike of the J46 fault (the photograph has been taken from the top of a 4 m high ramp used during the rehabilitation – notice the vent bag in the top left hand corner of the original drive profile).

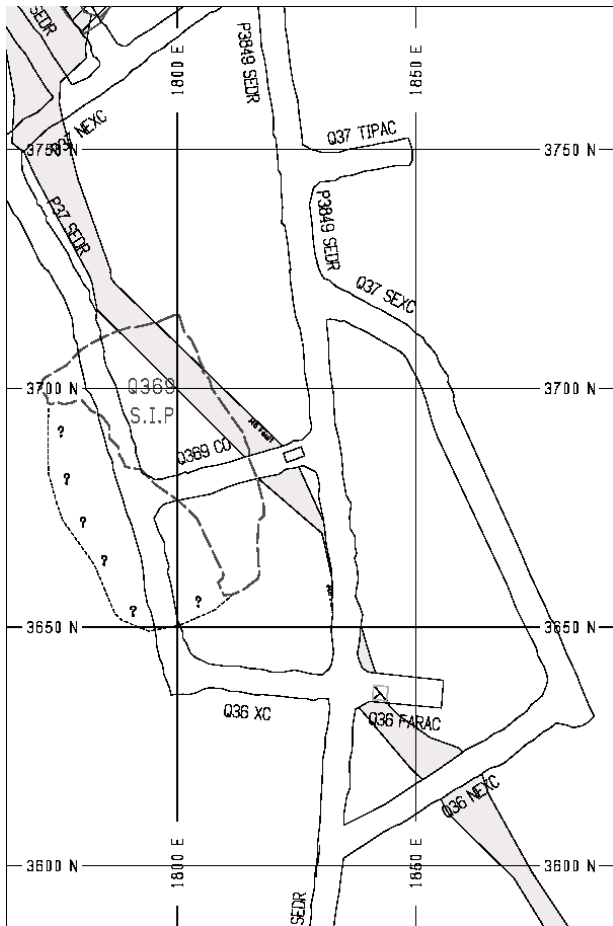
Figure 10. 20B Sublevel mine plan showing the Q37 SEXC and Q36 NEXC Bypass in relation to P3849 SEDR (the shaded area represents the floor projection of the J46 fault).

The bypass (Q37 SEXC and Q36 NEXC) was developed within Fractured Siliceous Shales, intersecting the J46 and L41 faults at its southern end (see Figure 10). The bypass was designed so as to intersect the fault normal to its strike (improved stability when compared to an intersection striking parallel). The development profile through the faults was maintained without any problems, with the installed ground control consisting of split sets, mesh in the back and down both sidewalls to the floor, 100 mm of shotcrete, and cable bolts. The ground control as a whole was installed as a complete system before the next advancing cut was taken.
