# A fall of ground case study – an improved understanding of the behaviour of a major fault and its interaction with ground support

I.G.T. Thin, B.J Andrew & M.J Beswick

*Xstrata Copper, Mount Isa Mines, Mount Isa, Queensland, Australia.*

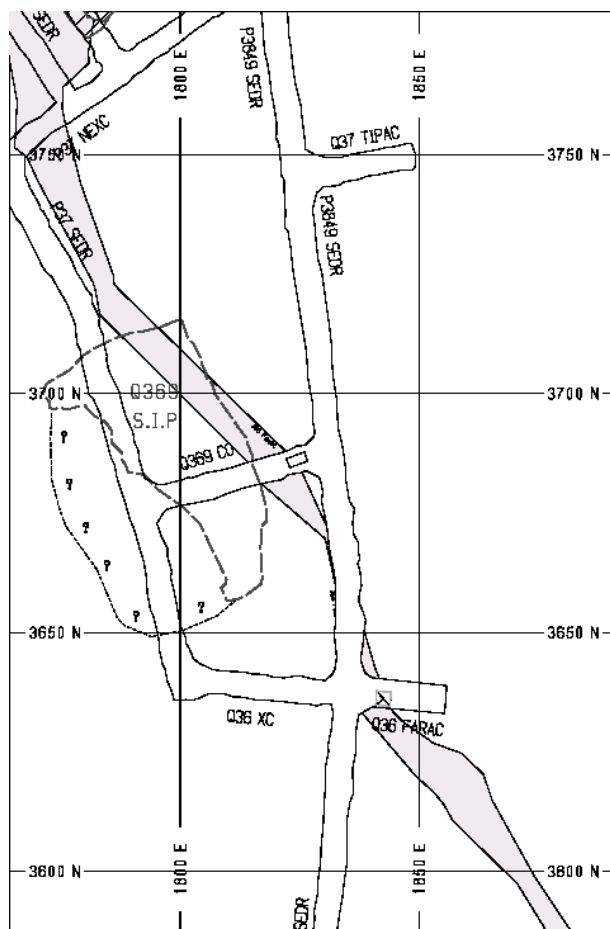
With regards to the specific location of the failure, this was along P3849 SEDR on 20B Sublevel, between Q369 CO and Q36 XC (see Figure 1). The failure initiated approximately midway between the Q369 CO and Q36 XC and arrested to the north of the P3849 SEDR and Q369 CO intersection. The zone of failure encompassed the area where the J46 fault intersects the main footwall drive.

Figure 1. 20B Sublevel mine plan showing the P3849 SEDR and surrounding Q369 stope development (the shaded area represents the floor projection of the J46 fault).
